PROCEEDINGS

AUGUST, 1953

STRUCTURAL OBSERVATIONS OF THE
KERN COUNTY EARTHQUAKE

by Henry J. Degenkolb

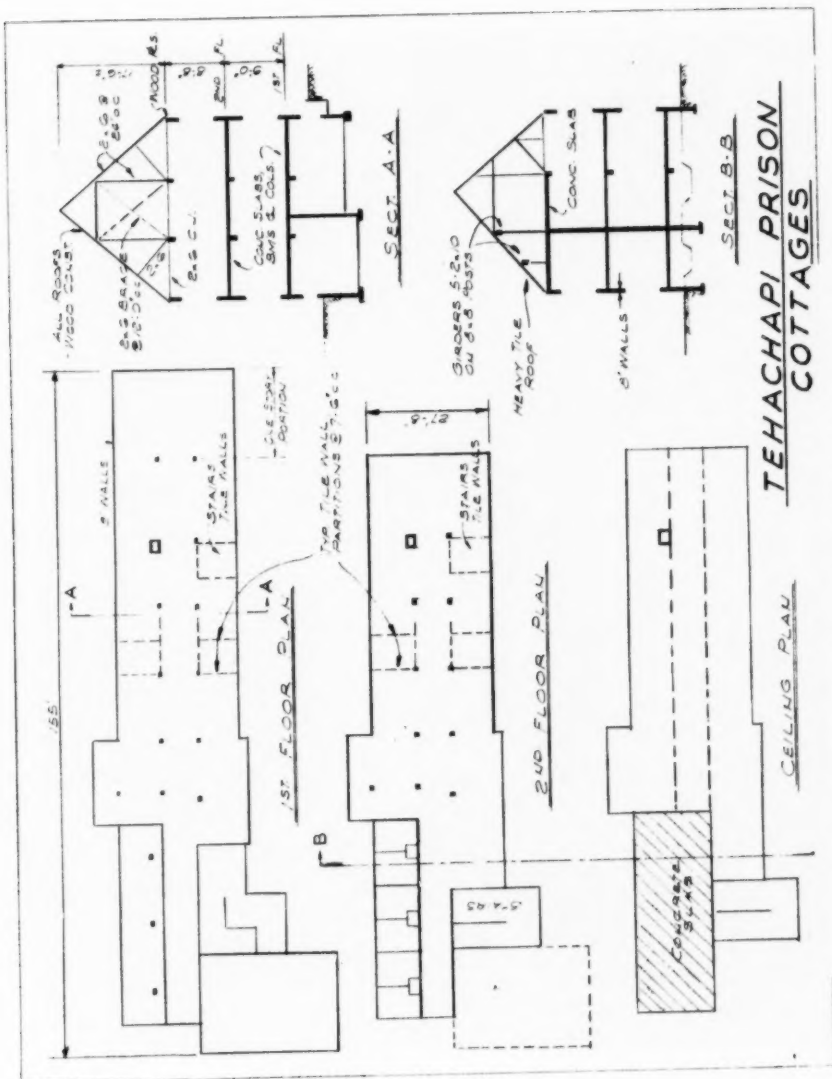
Fig. 13 Framing for typical Cottage at Tehachapi State Prison.

The Tehachapi State Prison for Women, built in 1932 and not designed for lateral forces, consists of a group of two story reinforced concrete buildings with steep pitched tile roofs on wood framing (Fig. 10). An exterior view of these buildings would indicate little damage except for the loss of some chimneys and some cracking, but the interiors show badly cracked tile partitions and a general shambles of the timber roof framing (Figs. 11 and 12). By the standards of present day lateral force design, the timber framing was particularly poor, using inadequate or no ties, and it is not at all surprising to see the amount of damage that occurred. Present codes, however, assign certain shear values for using tile partitions and other similar brittle elements, and on this basis the shear resistance of many partitions in the top floor would approximately meet present Uniform Building Code requirements due to the fact that these partitions were spaced quite closely to provide small rooms (Fig. 13). These partitions, however, were badly cracked (Fig. 14). This observation raises the question as to the adequacy of normal static shear tests, especially of brittle, weak materials to establish safe resistance values for earthquake loads. Present codes show an increasing tendency to permit use of these brittle materials such as plaster, plaster substitutes, hollow tile, weak deck fills, etc., as lateral force resisting elements by assigning allowable stresses for their use. At present, these values are based on static tests, and observations indicate that their performance in actual construction may not meet these expectations.

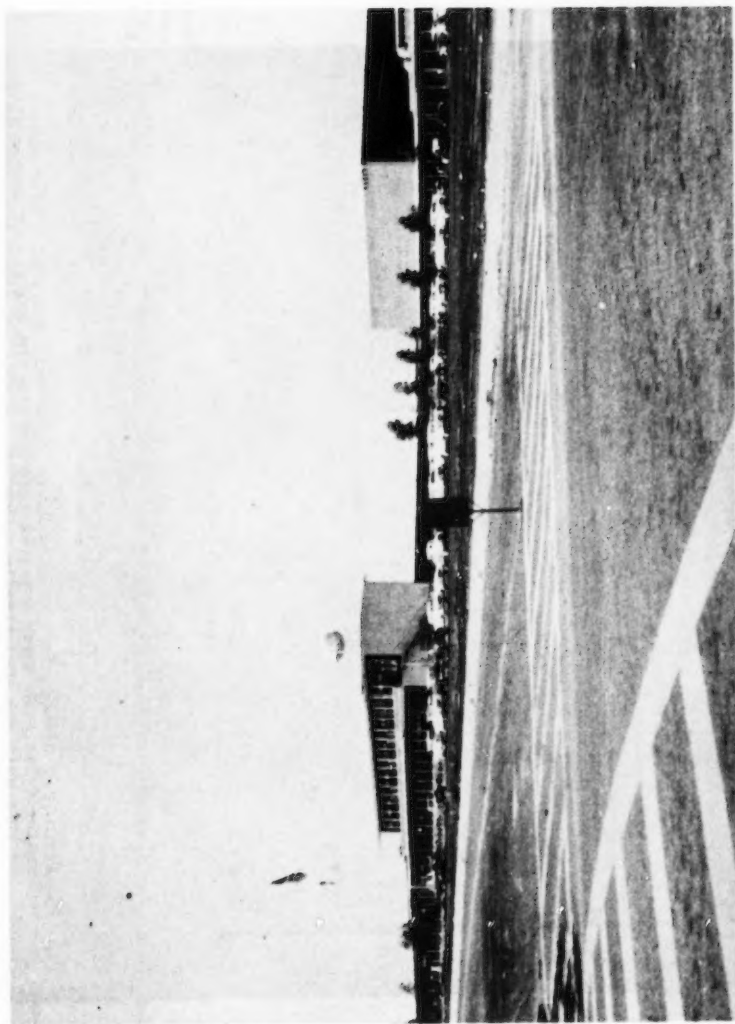
Fig. 15. Exterior of Arvin High School.

The Arvin High School (Fig. 15) is an excellent example of a building that is quite rigid, met code requirements for California Schools and, in general performed excellently. This large school, located comparatively close to the fault line, was evidently shaken quite severely. One shear wall suffered some damage by cracking (Fig. 16). This wall was constructed of grouted brick masonry, and according to code standards, was not highly stressed. However, field examination and later core samples indicated that the workmanship on this wall was poor, resulting in voids in the grout and inadequate bond to the reinforcing steel. The aftershocks of the earthquake caused this crack to

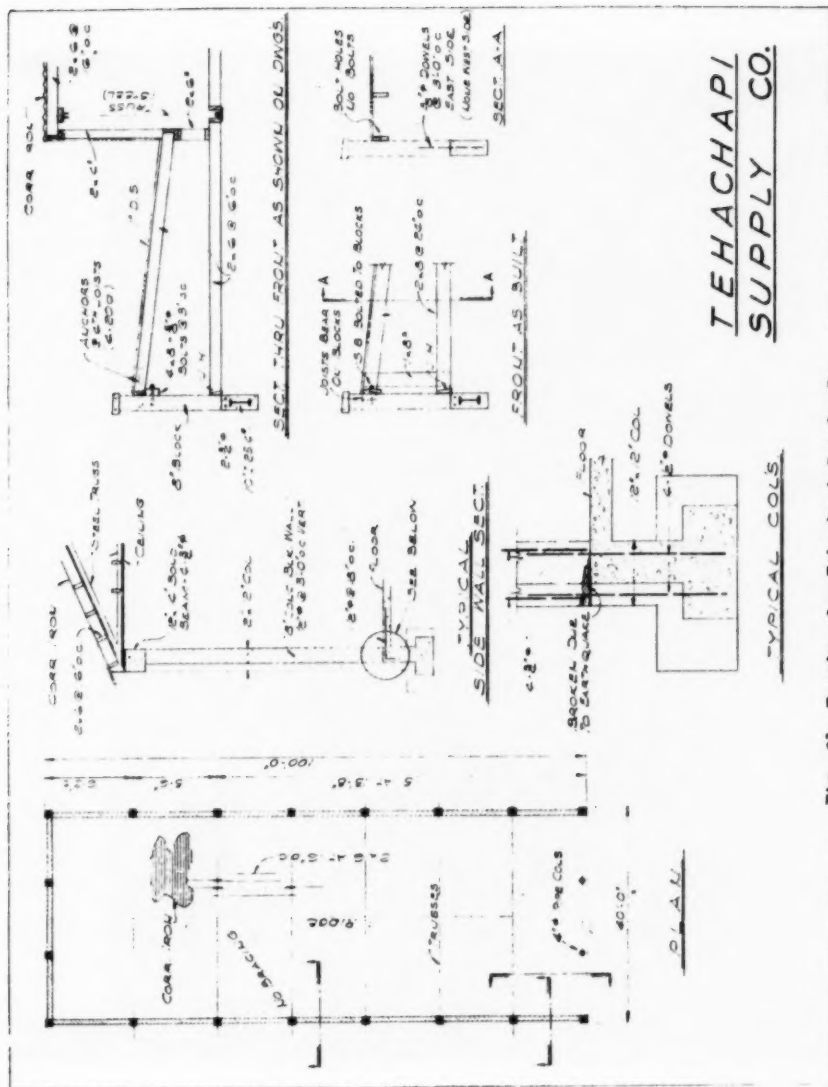
Fig. 21. Framing for Tehachapi Supply Co.

The building for the Tehachapi Supply Company (Fig. 20) was designed and built in 1946 during the material shortages. This building is 40' x 100', using concrete block walls with poured concrete columns and bond beams. Except for the first bay, which is timber, the rest is corrugated iron and there is no bracing as we ordinarily understand it (Fig. 21). However, some resistance is developed by the columns cantilevering out of the footings. At the base of the column, the dowels from the footings are 1/2" ϕ although there are 3/4" ϕ in the column. When the columns acted as cantilevers, they failed at the base (Fig. 22). There was little or no supervision of construction and changes were made from the design drawings. Dowels to parapets and bolts from wood roof to masonry were omitted while framing details were changed. As constructed, the building as a whole would "figure" for about 4%G or a 6# wind. In spite of the poor design and the poor construction due to lack of supervision, this building is usable and was open for business right after the earthquake. When the columns shattered, they permitted the building to act as a flexible structure and so prevented further damage, which could be interpreted as an interesting application of limit design. The cost of repairs for broken front windows, parapets, tops of front columns and column bases was not great to bring it back to its original condition, but it would have been expensive to bring it up to any code requirements.

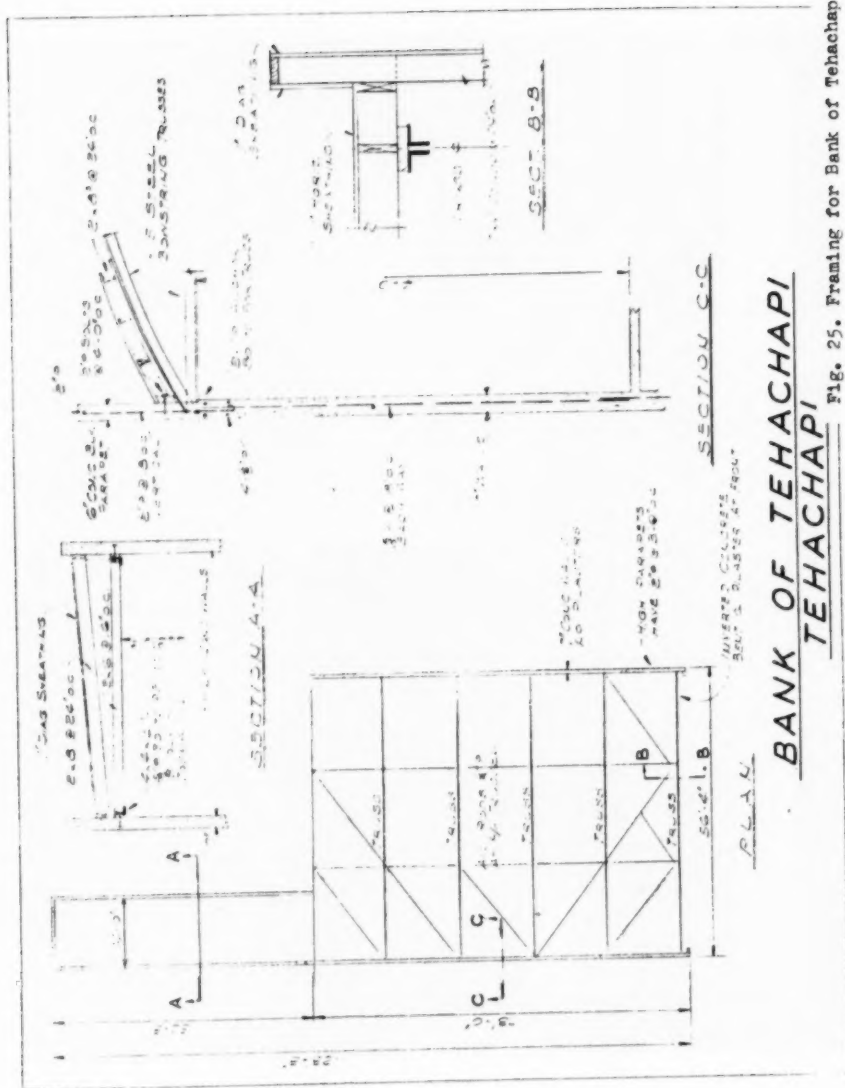
Fig. 25. Framing for Bank of Tehachapi.

building is 56' x 73' with a long low appendage at the rear. It has 7" reinforced concrete walls with steel bowstring trusses providing a 14'-0" ceiling (Fig. 25). There was a wood roof using straight sheathing with a rod bracing system. At the rear of the bank this long appendage had a diagonal sheathed roof with no joint anchors. Based on the Uniform Building provisions, this portion had a lateral load of 200#/ft. on a 50' span, the diaphragm being 14' deep which gives an end shear of 360#/ft. The front is of wood and stucco with an inverted concrete bent taking the lateral loads. According to Uniform Building Code provisions, the rods are stressed to 37,000# per square inch with rather inefficient details for the rods. There was little damage except to the front and to the parapets which fell off (Fig. 26). Note that while the parapet was reinforced with $1/2" \text{ } \phi @ 3'-0"$, there were no dowels for the portion of the parapet that broke off.

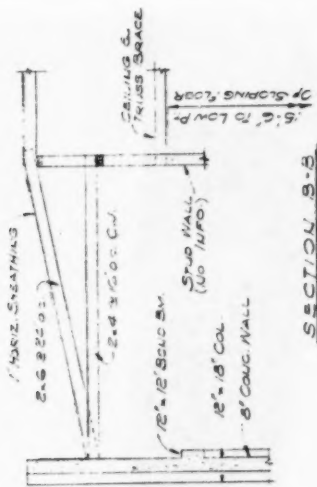
Fig. 28. Framing for Bekay Theater.

The Beekay Theater (Fig. 27) in the center of the damaged area was undamaged except for a small crack in the wall on the far side. This building is 43' x 75' with 8" reinforced concrete walls between 12 x 12 columns and bond beam (Fig. 28). These supported 3 bowstring timber roof trusses, wood purlins and straight wood sheathing. It has $5/8" \text{ } \phi$ rod bracing in the plane of the lower chord but this ends at the lobby stud wall. The so called plans of this building were very meager. For such a major building element as this wall, there was absolutely no information on the drawings and the plaster prevented a determination of the construction below the ceiling. Assuming the wall to be an adequate shear resisting element (which I personally doubt), the rod bracing is good for about 11%G on dead load only with a shear in the wall of about 350#/ft. The calculated deflection due to the rod system is about 1", assuming rods tight, and neglecting such items as bolt slip and deformations in the shear walls. The maximum permitted by one proposed formula is .8" and must include these effects.

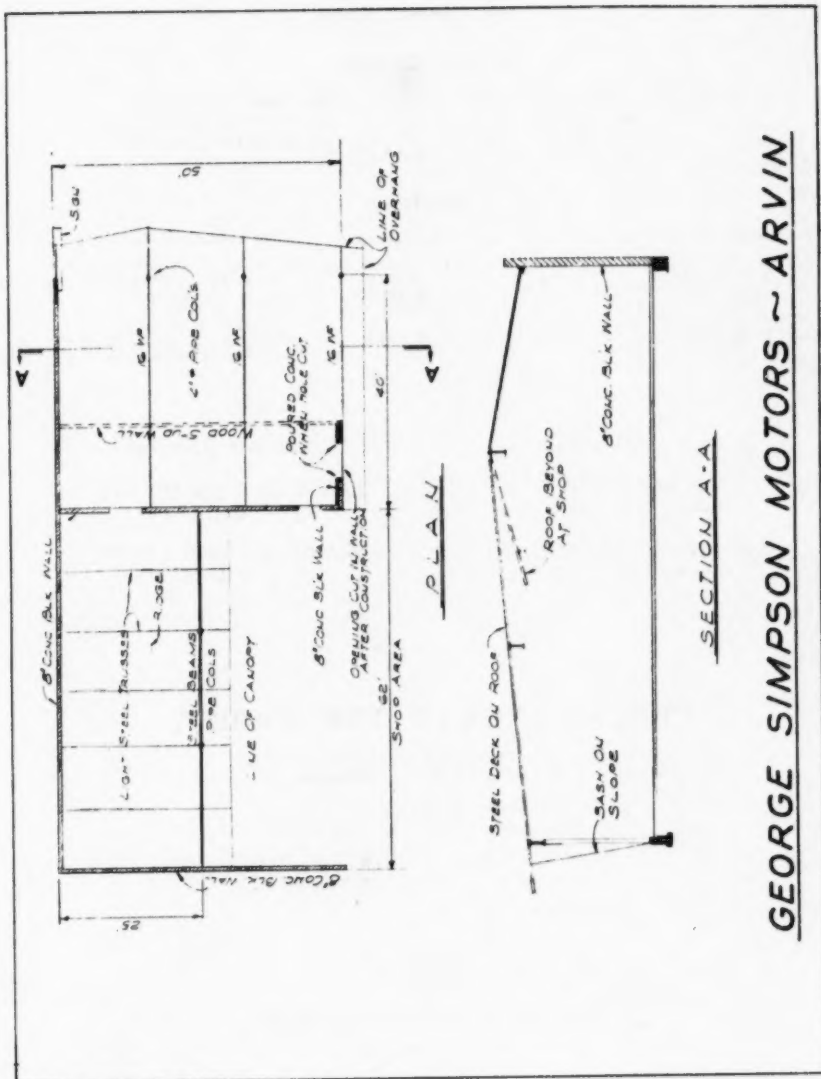
Fig. 30. Framing for Simpson Motors.

To me the most interesting building in the area was this Auto Sales Agency in Arvin (Fig. 29). Designed and closely supervised by both an architect and an engineer, it suffered the damage of only two cracked panels of glass and a small crack in the masonry over the side door. The framing (Fig. 30) is very simple, using steel beams and columns, a metal roof deck acting as a diaphragm, and unreinforced concrete block walls as resisting elements. However, all the basic elements of lateral force resistance are present and the structure is well tied together, and the results achieved were outstanding, proving that this type of modern architectural design can be made safe for earthquakes.
